National Dam Inspection Program.

~~FEDERAL~~ SHEPPARD Dam

(NDI ~~NO~~ ^{Number} PA-00333,

PHASE I INSPECTION REPORT,
NATIONAL DAM INSPECTION PROGRAM

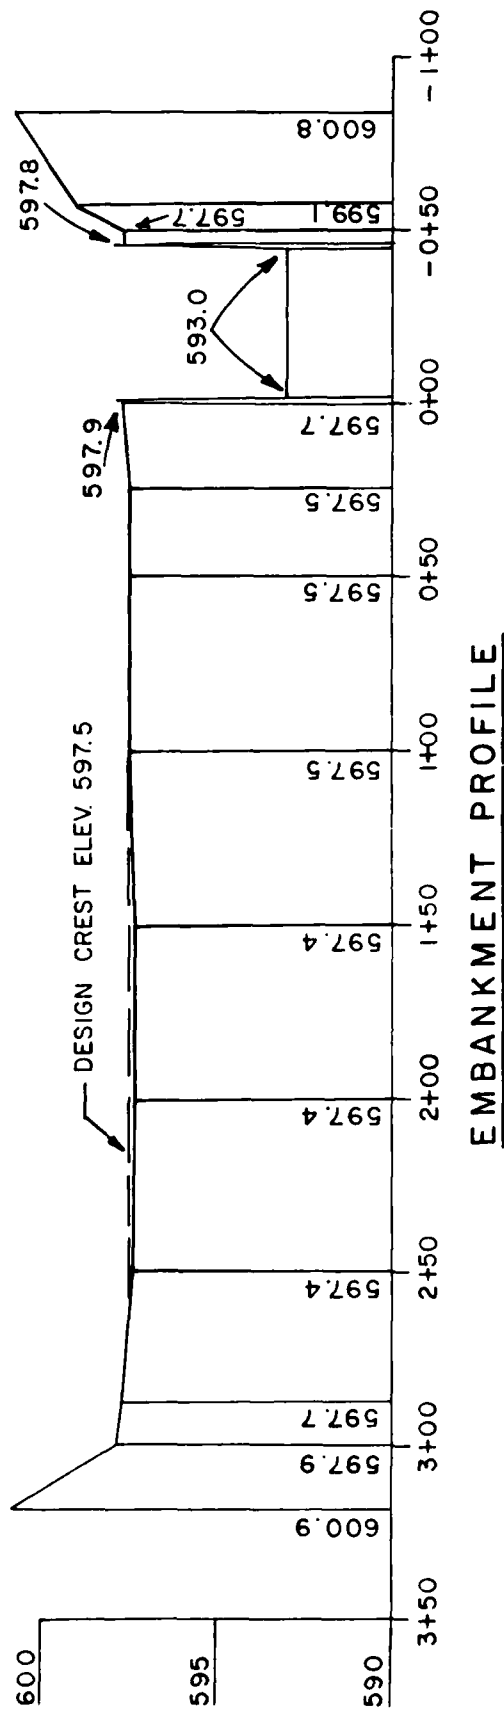
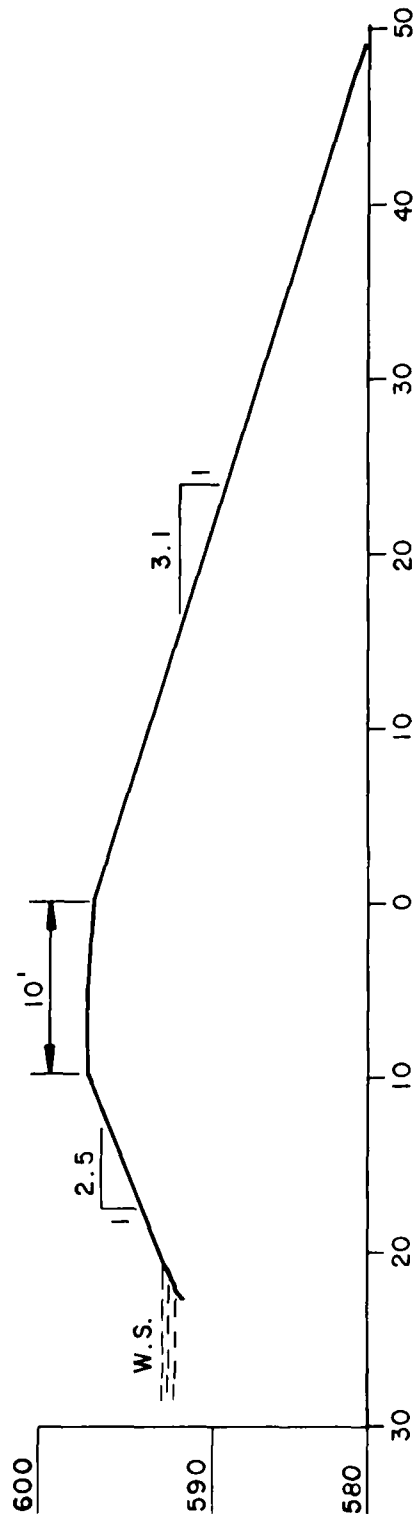
SHEPPARD DAM
PA - 00333
INSPECTION SURVEY
PLATE A-I

EMBANKMENT SECTION

STA. 1+25

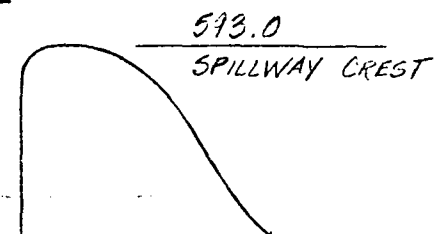
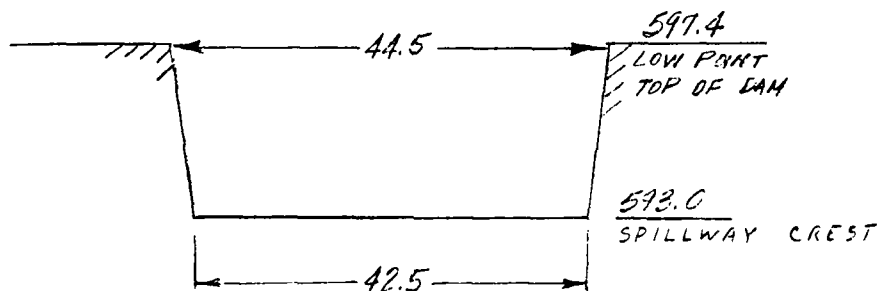
SPILLWAY RATING

$C=3.88$ (SMALL DAMS, FIG. 249)

$$Q = CLH^{3/2}$$

$$Q = 3.88 \times \frac{42.5 + 44.5}{2} \times (597.4 - 593)^{3/2} = 1556 \text{ cfs}$$
